Property name: Fat Oxen

Location: Urbana Pike (MD 355), Frederick, Frederick County

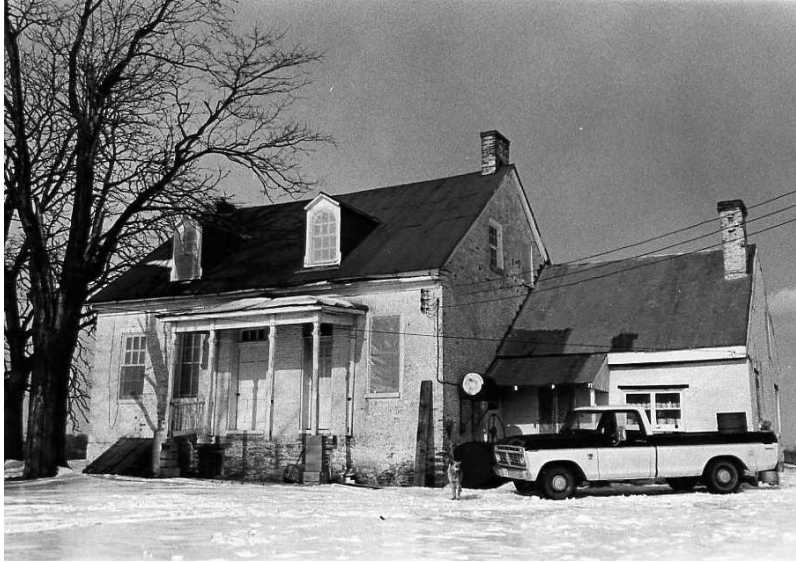
Photo credit: Jack L. Finglass, Winter, 1976

Description: Fat Oxen is unpretentious, yet elegantly refined. Constructed of Flemish bond brick and facing southwest, the house rises from a knoll 1 1/2 stories over a high rough stone foundation. The kitchen wing is attached to the southeast elevation and is also 1 1/2 stories in height, although shorter. Both the main block and subsidiary wing are unusually deep for a house of this scale. The roof rises at a very gradual pitch. Fat Oxen dates from the third quarter of the 18th century and is basically Georgian vernacular in style. The house has two double parlors with a partially open center hall and is five bays wide and two bays deep. The wing is two bays wide and two bays deep. A high wooden mid-19th century porch with railings shaded the two doors on the facade until it was removed in 1976. The doorway in the third bay is original. The subsidiary door in the fourth bay appears to have been added at a later date. Perhaps this doorway was a window at one time. This change would greatly enhance the stylistic refinement. Both doors have two-light transoms. Two gable-roofed dormers with round-arched 6/6 sash windows pierce the roof on the southwest facade. A basement bulkhead entrance is located at the northwest corner of the structure. Most window sash are 6/6. Central enclosed chimneys are found at either end of the house and an extremely wide stone chimney originally covered the southeast elevation. A more modern brick stack now rises through the southwest side of the roof at the gable end. The rear elevation has been greatly altered throughout the life history of the structure. However, the original 18th century door frame and 9/9 sash remain. The interior of Fat Oxen exhibits many alterations, and woodwork from every period can be found. However, much of this woodwork is of great merit, including beaded chair rails, baseboards, flat paneled shutters in the window reveals, and interior doors. Each of the four main rooms in the main block have back-to-back interior corner fireplaces. The mantels are rare due to the fact that the raised paneled over-face design continues down only one side of the fireplace opening. This design alternates from the left to the right side of the opening, depending on which direction the opening faces. The chimneys are rare in that they are asymmetrically placed along the roof ridgeline. This arrangement is most evident at the basement level. Only one brick hearth remains visible. The period stairway exhibits heavy molded handrails and simple rectangular balusters. A heavy chair rail runs across the stair landing and continues to the second floor level. The basement area is perhaps

one of the few intact period cellars in the area. A finished wooden stair descends from under the main stair to the dirt floor. Original plank partitions and sorting bins are extant in the southeast half of the basement.
